How severely does rust damage the side walls of a web press?

AN EXPERT REPORTS FROM THE COAL FACE (17). A one-year old newspaper press displays visible rust on the inner surfaces of the side walls. At the request of the press manufacturer and the customer, the cause and extent of the damage, possible further damage and the elimination of the damage are to be documented in an out of court expert opinion.

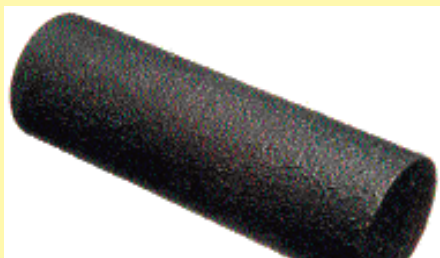
Figure 1a: Cast iron specimen from the outer side of the side wall.

The samples that had been positioned on the external, painted surfaces of the side wall

showed no traces of corrosion. On the other hand, the cast iron specimens positioned on the inner surfaces of the side walls had suffered a similar corrosive attack to the surfaces of the side walls themselves.

WHERE DOES THE RUST COME FROM? Figure 1a is an example of a specimen from the outer surface of a side wall, whilst figure 1b shows a specimen from the internal side wall.

hibiting oil, cylindrical cast iron specimens were sprayed with a selected corrosion inhibiting oil and then positioned for three months at various points on the inner surfaces of the side walls. The result was striking. At the end of the three month trial, the specimen looked the same as it did before the test (figure 1a).

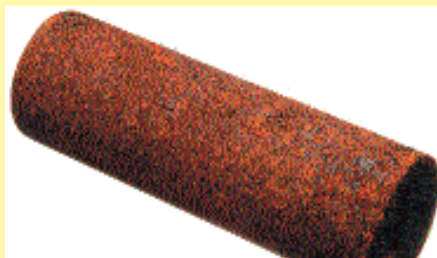
The rust that develops on the inner, unpainted surface of the side wall is due to damping solution from the spray damping units of the press. However, both the water used and the fountain additive lie within the limits laid down in the guidelines of the press manufacturer.

Figure 1b: Cast iron specimen from the inner side – showing corrosive attack.

On the recommendation of the expert, the inner surfaces of the side walls were cleaned of rust and the sprayed with the previously tested and effective corrosion inhibiting oil. The advice of the expert is that the inner surfaces of the side walls should be regularly sprayed every three months. The press manufacturer undertook to meet the labour costs for removing the rust and the corrosion inhibiting oil costs for one year.
